2014 Ram 1500 EcoDiesel Long-Term Road Test

2014 Ram 1500 Ecodiesel: Back in Service

March 3, 2015

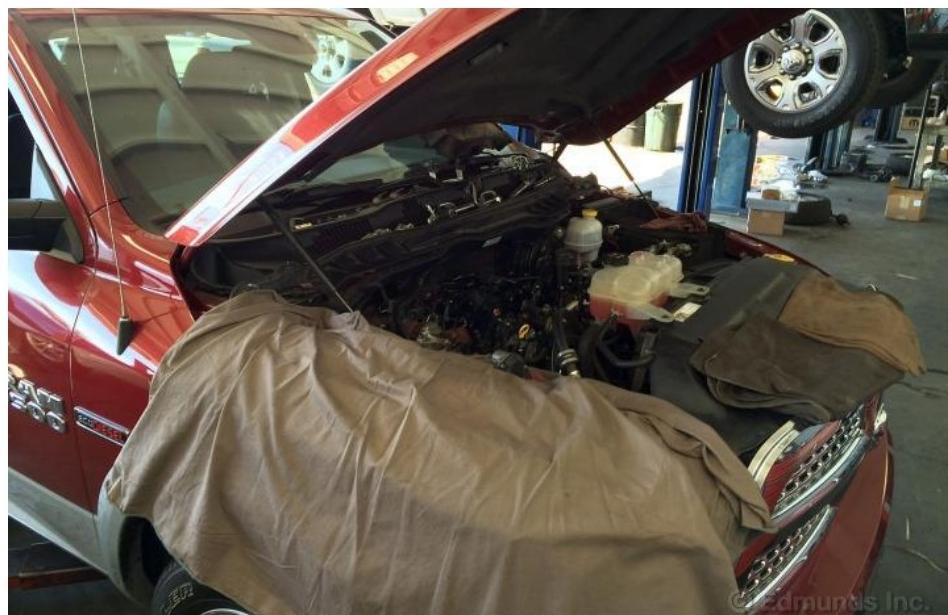
The work ticket also lists the original trouble codes as P0087 and P016F, which have to do with low fuel rail pressure. (Two fuel rails sit underhood and feed three fuel injectors each). The mechanic and the district service rep didn't suffer a stall during their test drives, but they did experience the long crank and observed sluggish response under heavy acceleration, a symptom I hadn't experienced because I hadn't been hauling cargo or hauling butt in the days leading up to the stall.

Think of the canister as a bucket. When the tank is full the canister is naturally filled with fuel because it's submerged. But it stays full even as the tank level drops below the lip of the bucket because a) the fuel return line dumps into the canister and b) the pump draws fuel in through a tiny orifice in the bottom. In this way the pump, which is inside the canister, is always bathed in fuel even if the tank level outside drops lower than the lip of the bucket.

They ruled out the possibility of contaminants in the tank or the fuel after they drained and inspected the tank. They also ruled out canister damage from external sources such as a piece of freeway debris or a direct off-road rock hit after their inspection showed no witness marks or dents in the tank.

At this point the specific reason for the low rail pressure and source (and extent) of the debris in the high-pressure part of the fuel system remained unknown. They had theories, but testing them would take time.

So they decided to remove and inspect the entire fuel system from the in-tank canister and its submerged feeder pump to the injector pump to the fuel rails and the injectors themselves. That's pretty much the entire fuel system downstream of the tank itself, except for the fuel lines along the frame rails, which can be flushed and cleaned.

The inspection — more of a dissection, really — would occur in Detroit, so they ordered a laundry list of new replacement parts for our truck, all under warranty. Waiting for the parts to arrive from their various warehouses took most of the time. Many of the pieces are not regular service items that are normally stocked at the local depot.
